Fine sediment storage in an eroding forest trail system

Jonathan D. Phillips

ABSTRACT

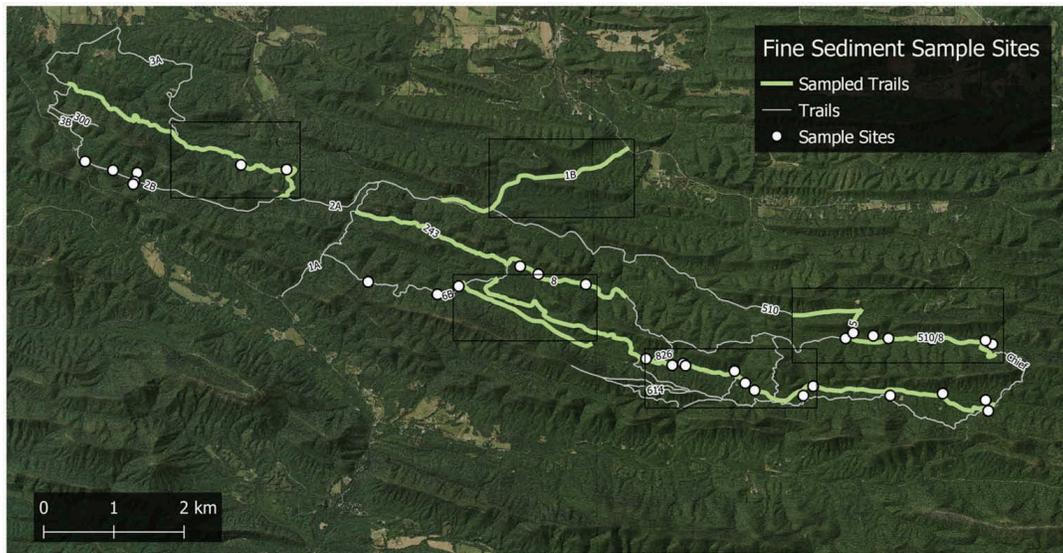
Figure 1. Study area map showing trail sections surveyed for fine sediment accumulations and stream sample sites.

The WPG Trail Complex is in the Ouachita Mountains of western Arkansas and is part of the upper Board Camp Creek drainage basin (Figure 1). The trail complex includes about 70 km of loop trails, with additional FS unpaved roads used by OHVs connecting WPG to county and state roads. WPG trails are variously open to all-terrain vehicles (ATVs), trail

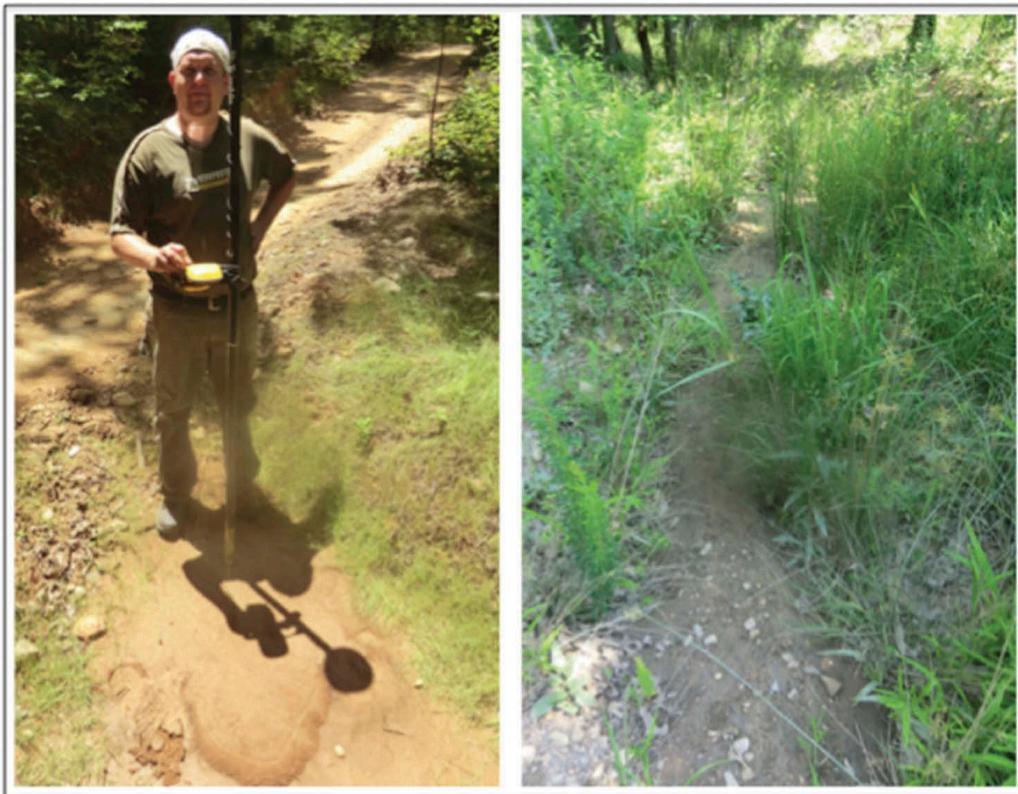
Figure 2. Trailside fine sediment accumulations. Left, a filled sediment trap. Right, a silted natural ephemeral channel.

reported by Phillips and Marion (2020). Natural topographic and drainage features were the dominant FSA sites examined, including 45 channels that were dry at the time of sampling (36% of the total) and 26 channels with flow (21%). These were trailside channels such as that shown in Figure 2, and are not included in the stream sampling. The accumulation sites also included six hollows or unchannelled valleys, two of which had underlying culverts. Water or sediment control features accounted for 45 FSA sites (35%), including 15 wing ditches and 30 sediment traps (Figure 2).

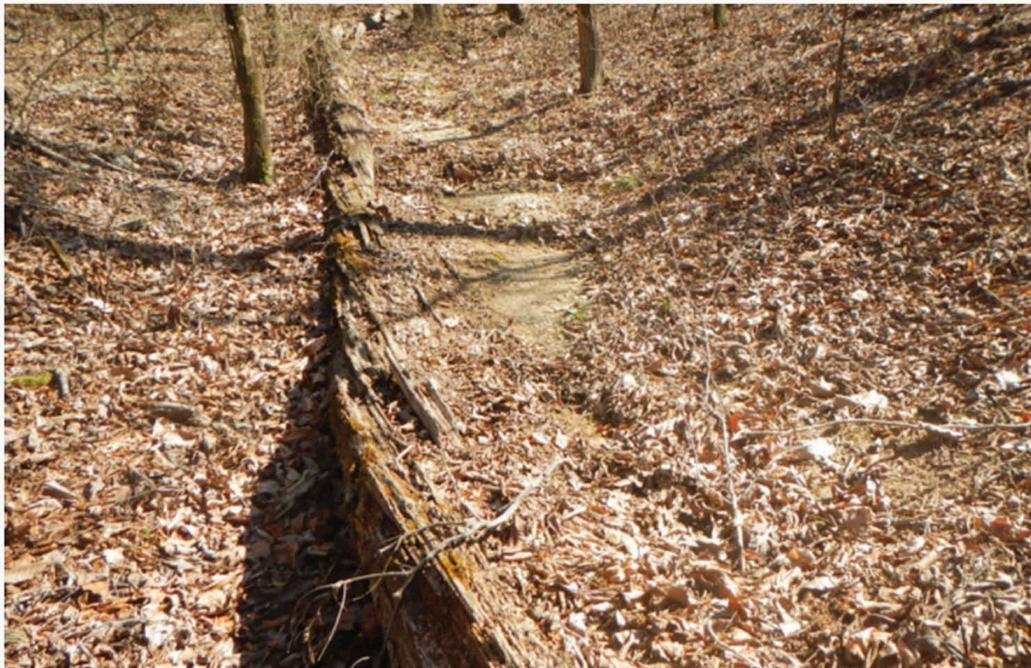
Figure 3. Fine sediment accumulated behind a log in an unchannelled valley (hollow).

Results also suggest the importance of high-accumulation “hotspots” (Figure 3). The single largest measured sites accounted for about 50% each of ephemeral channel and wing ditch deposits; nearly 30% of the FSA in first-order channels; and more than 90% of FSA in hollows.

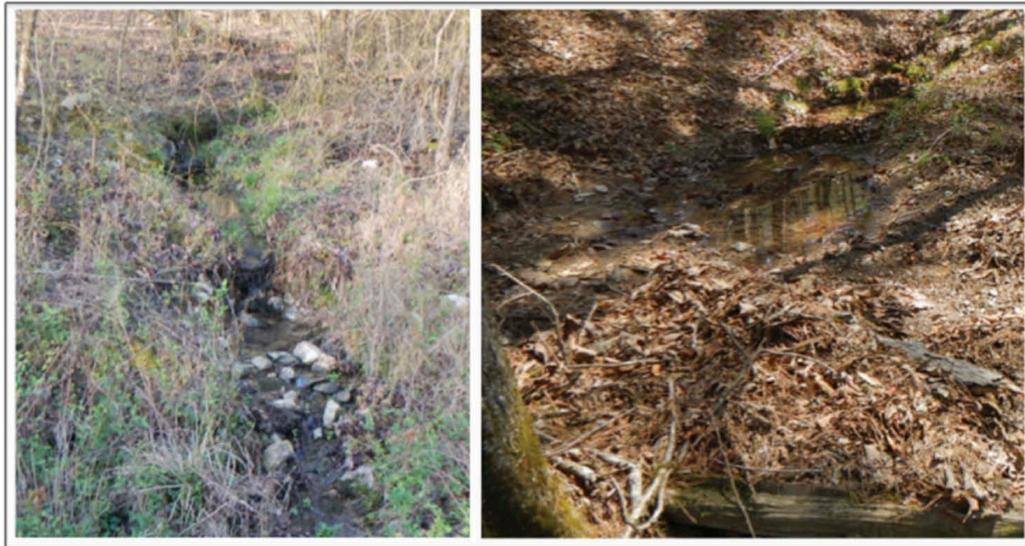
Figure 4. FSA examples in sampled headwater streams. On left, a typical reach with very little FSA. On right, a localized accumulation behind coarse woody debris.

0.030 m³ per m² of channel bed area, equating to a mean depth of <3 cm. FSA examples for these channel types are shown in [Figure 4](#).

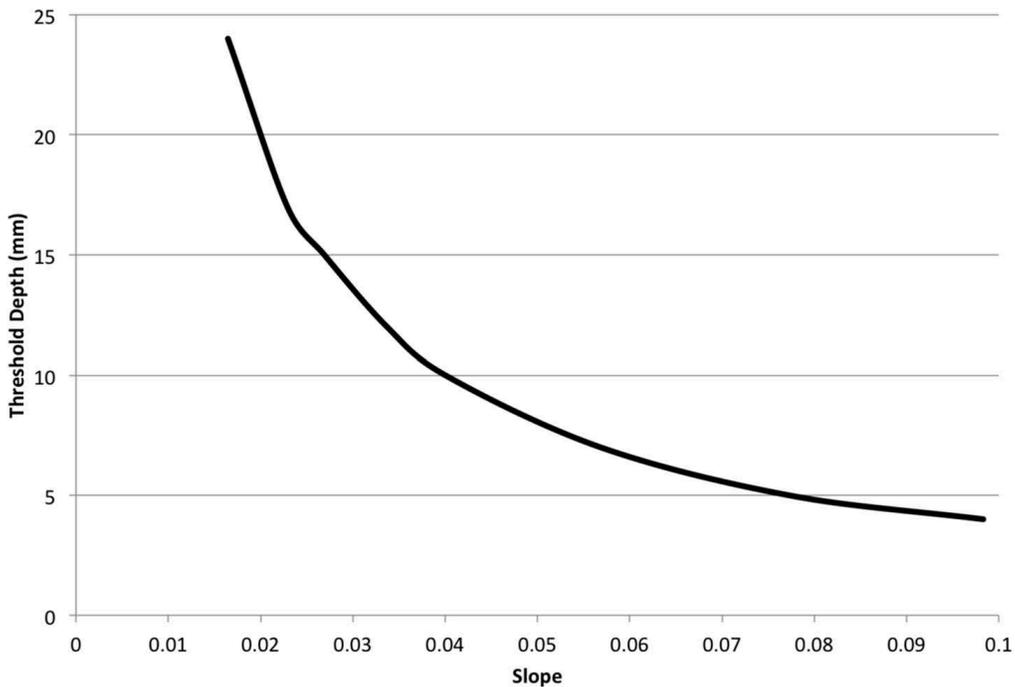
Figure 5. Minimum depth necessary to transport an 8 mm median diameter particle for the range of slopes shown in Table 6.

Table 6 shows slope gradients for small channels where trailside FSA was measured, and for sampled stream segments. The mean boundary shear stress equation was used as described in the methods section to determine the flow depth required to entrain particles ≤ 8 mm for the range of *S* (slope) values shown in Table 6. Results are shown in Figure 5.

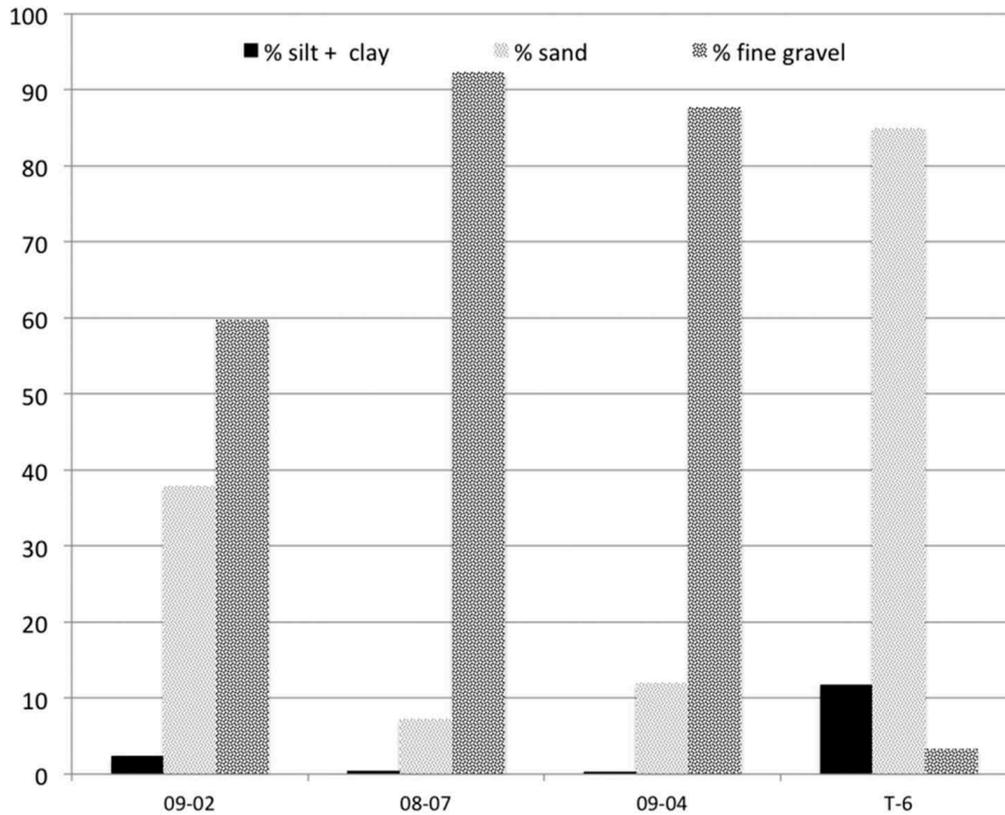
Figure 6. Grain size of low-order stream sediment samples. Fine gravel, in this case, includes particle diameters 2–8 mm.

To better describe the grain-size composition of FSAs within small channels, substrate samples from four sites were collected and analyzed. Bulk samples of 150–250 g were excavated from measured FSA deposits by digging vertically about 10 cm with a hand trowel. Each sample was oven-dried and analyzed using a half-phi sieve stack and standard gravimetric procedures.

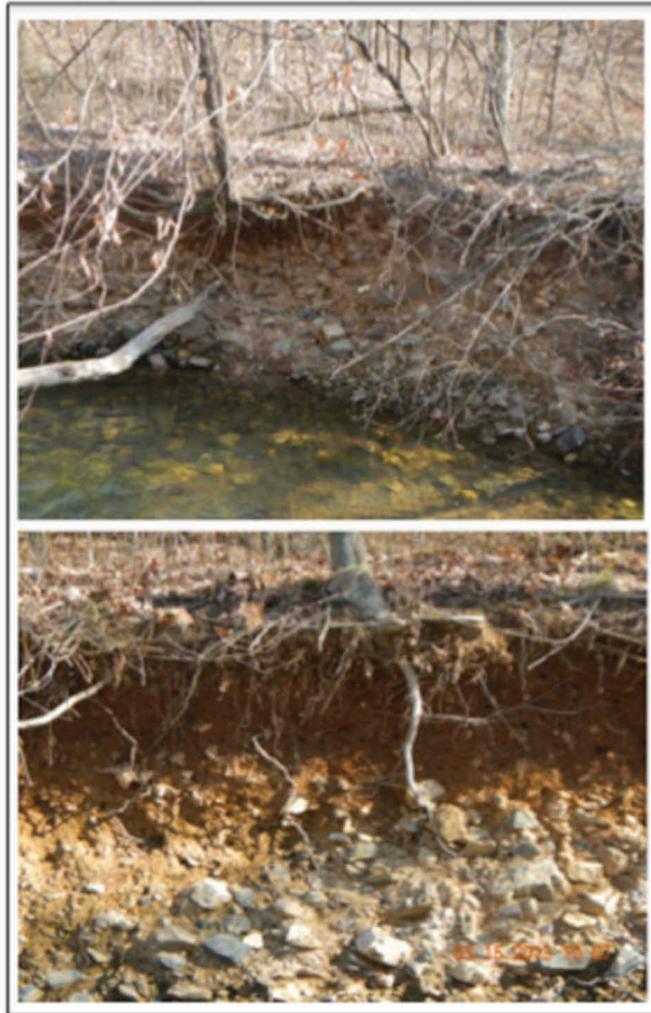
Figure 7. Example exposures of Ceda (top) and Kenn (bottom) series.

majority along Board Camp and Gap Creeks, accounting for a total of about 367 ha. The Ceda series typically has 35% to 70% coarse fragments by volume, with 30% to 65% fines (clay to sand). Kenn series soils are about 35% to 70% fines. The Kenn-Ceda complex mapped in the area is about 60% Kenn and 30% Ceda soils (and 10% others). The Kenn series (Ultic Hapludalfs) has pedogenic evidence of significant residence time, including an argillic horizon, clay films indicating translocation, and weak subangular blocky structure in the subsoil. The Ceda (Typic Udifluvents), by contrast, is minimally developed, with an A-C profile and no structural development below the A horizon ([Figure 7](#)).
